# Wascana Centre Authority

## Comprehensive Review Project

#### Building and Infrastructure Assessments

# Report

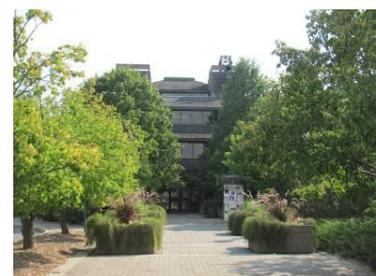
The facility sits on a concrete foundation complete with concrete slab on grade. Stained cedar walls and a cedar shake roof covering provide the envelope for the facility. Cedar walls and cedar shakes installed on the roof have become damaged and worn and require replacement. One large skylight has been installed. Exterior doors in the facility are aluminum, steel or wood. Exterior steel doors have worn finishes as does the exterior wood door. Exterior windows in the facility are aluminum. Overhead doors in the facility are wood. Overhead wood doors in the facility are sagging and worn and require replacement.

The boilers are original with primary only pumping. The boilers are past the intended design life, are inefficient and are poorly controlled. The boilers should be replaced with new near condensing boilers, piped in a primary secondary arrangement. VFD's should be added to the secondary system pumps.

The Outdoor Condensing units and evaporator coils are original. The condensing units and coils are past their intended design life use R-22 refrigerant which is in the process of being phased out. The condensing units and coils should be replaced with new condensing units that utilize a non-ozone depleting refrigerant.

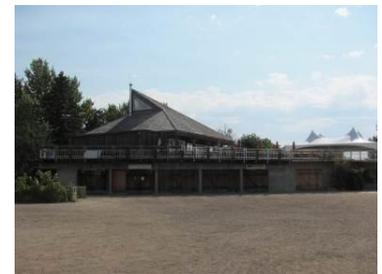
The facility substructure consists of concrete strip footings, foundation walls, and slab on grade. Exterior walls are cast in place concrete below grade with wood cladding above grade. Exterior windows are sealed units set in wood frames in the original building, and aluminium framed windows in the 2005 addition. The original exterior passage wood windows are deteriorating with localized rot and should be replaced. The solid wood exterior doors have some damage that should be addressed and the 2005 addition steel doors are in good condition. The overhead doors on the lower level are solid wood barn door style. A small portion of the flat roof covered with SBS roofing is retaining some water ponds and the insulation should be re-sloped and roofing replaced.

Furnaces and air conditioners serving the various tenant spaces have been installed within the last 5 years and are in good condition. The ductwork original to the building is rusted and needs cleaning, and insulation is damaged. Programmable thermostats are installed and in operation.

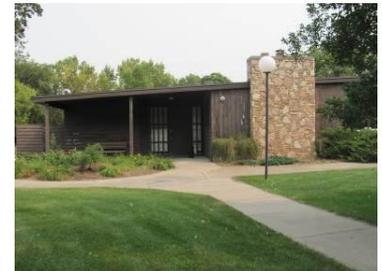
The facility substructure consists of concrete strip footings, foundation walls, and slab on grade. An extreme amount of water was noted in the basement of the facility and corrosion was noted on structural teleposts. Retain a foundation consultant to analyze and make recommendations for remediation. Exterior walls are clad with wood siding which is damaged and requires attention. Exterior windows are sealed units set in wood frames. Exterior passage doors include both solid core wood and insulated steel units. Other doors include a 10' x 7' sliding wood door that is damaged and an 8' x 8' overhead door. The roof covering is a rolled bituminous membrane (SBS) that was installed in 2008.

Partitions in the building include chain-link fencing. Interior doors are wood and require refinishing. Wall finishes are taped gypsum wallboard as well as ceramic tile, wood wall panels, and vinyl. Floor finishes include resilient flooring, sheet carpet, and plywood flooring. Asbestos tile resilient flooring in the building requires attention as some areas are worn and damaged, creating potential health risks. Retain a hazardous materials consultant to analyze and make recommendations for remediation. Ceiling finishes include gypsum board, fixed ceiling tile, and painted plywood. The fixed ceiling tile is worn, stained, and requires attention.

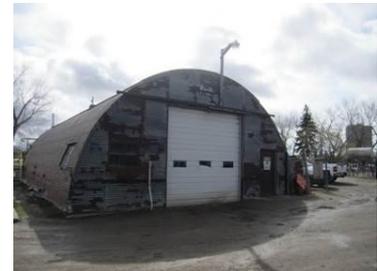
The facility substructure consists of concrete strip footings, foundation walls, and slab on grade. Exterior walls and roof are constructed of painted galvanized ribbed steel. The paint finish is worn and exterior walls are damaged on north side. Exterior windows are single glazed units set in steel frames. These windows do not provide proper heat and energy management. Exterior passage doors include insulated steel units. Other doors include a 12' x 12' overhead door complete with motorized operation.

Partitions in the building are gypsum wallboard construction. Interior doors are wood. Wall finishes are taped gypsum wallboard which is damaged. Floor finishes include the concrete slab which contains minor cracks and 12" vinyl composite tile flooring in the washroom which is damaged. Ceiling finishes include gypsum board.

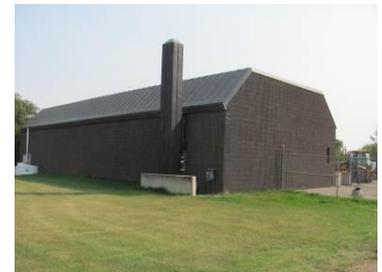
The copper roof covering is set upon a 2' x 10' joist frame that rests on masonry walls with a fluted face. The exterior windows are a mixture sealed and unsealed units. The unsealed units should be replaced to increase the efficiency of the building. The exterior passage doors are metal clad and the three overhead doors are wood. The overhead doors are damaged and require replacement.

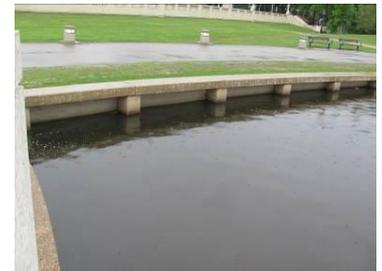
The north shore retaining wall was constructed in 2004 and is constructed of concrete panel sections and concrete wall sections on piles with an exposed aggregate finish. In general, the wall is in good condition and at the northeast a void is to be filled behind the wall.

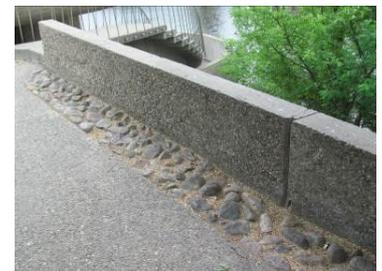
### 3.6.2 East Shore Retaining Wall by Willow Island (Area 2)

The retaining walls along the shore adjacent to the Willow Island Overlook were constructed in 1964 and are cast in place concrete on piles with an exposed aggregate finish. In general, the walls are in good condition, however vertical cracks along control joints have developed and the cracks require sealant to prevent water migrating into the concrete.

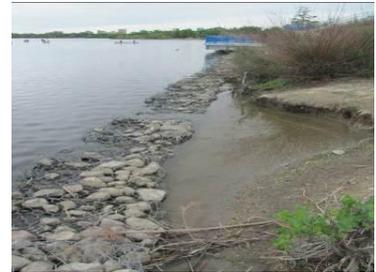
### 3.6.3 Pine Island Main Shoreline (Area 3)

Pine Island was constructed in 2004. The shoreline is protected by a series of gabion baskets and they are in fair condition. At the southwest corner, gabions have shifted and deformed. Gabion baskets are damaged and missing rocks along the west side. The terraced upper viewing area is constructed of cast-in-place concrete retaining walls and is in good condition.

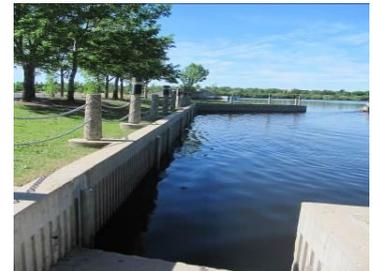
The former bridge abutment where the new waterfall structure is supported is in fair condition and exhibits some cracking, localized damaged areas, staining and moss growth. A large vertical crack (5-10mm) at the corner between west wingwall and backwall of abutment was observed however the concrete is still sound around the crack. A large vertical crack was observed at west side of backwall (20-30 mm) and there is staining and weak concrete. On the east side of the backwall, a concrete core (300 mm deep X 100 mm diameter) was observed as well as an intermediate crack (4mm) with weakened concrete around damaged area. A large vertical crack (15-20 mm) was also measured. Along the top of the backwall, the concrete is damaged and a crack (2 mm) is located where the wingwall meets the backwall on the east side. The aged concrete requires repair.

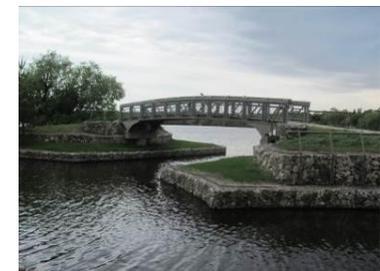
The bridge was constructed in 2004 and is a single span steel through truss bridge with wood decking and is in good condition. Some settlement has occurred along the west sides of both approach pathways and additional granular fill is required. Timber decking at the south abutment is to be repaired, guardrail bolting at one location on the east needs tightening, and guardrail spacer blocking on the west requires replacement. Portions of the grouted rip rap at the headslopes of both abutments are missing and require replacement.
