WASCANA CENTRE LANDSCAPE ASSESSMENT

FINAL REPORT

Submitted to
Wascana Centre Authority

By
Crosby Hanna & Associates

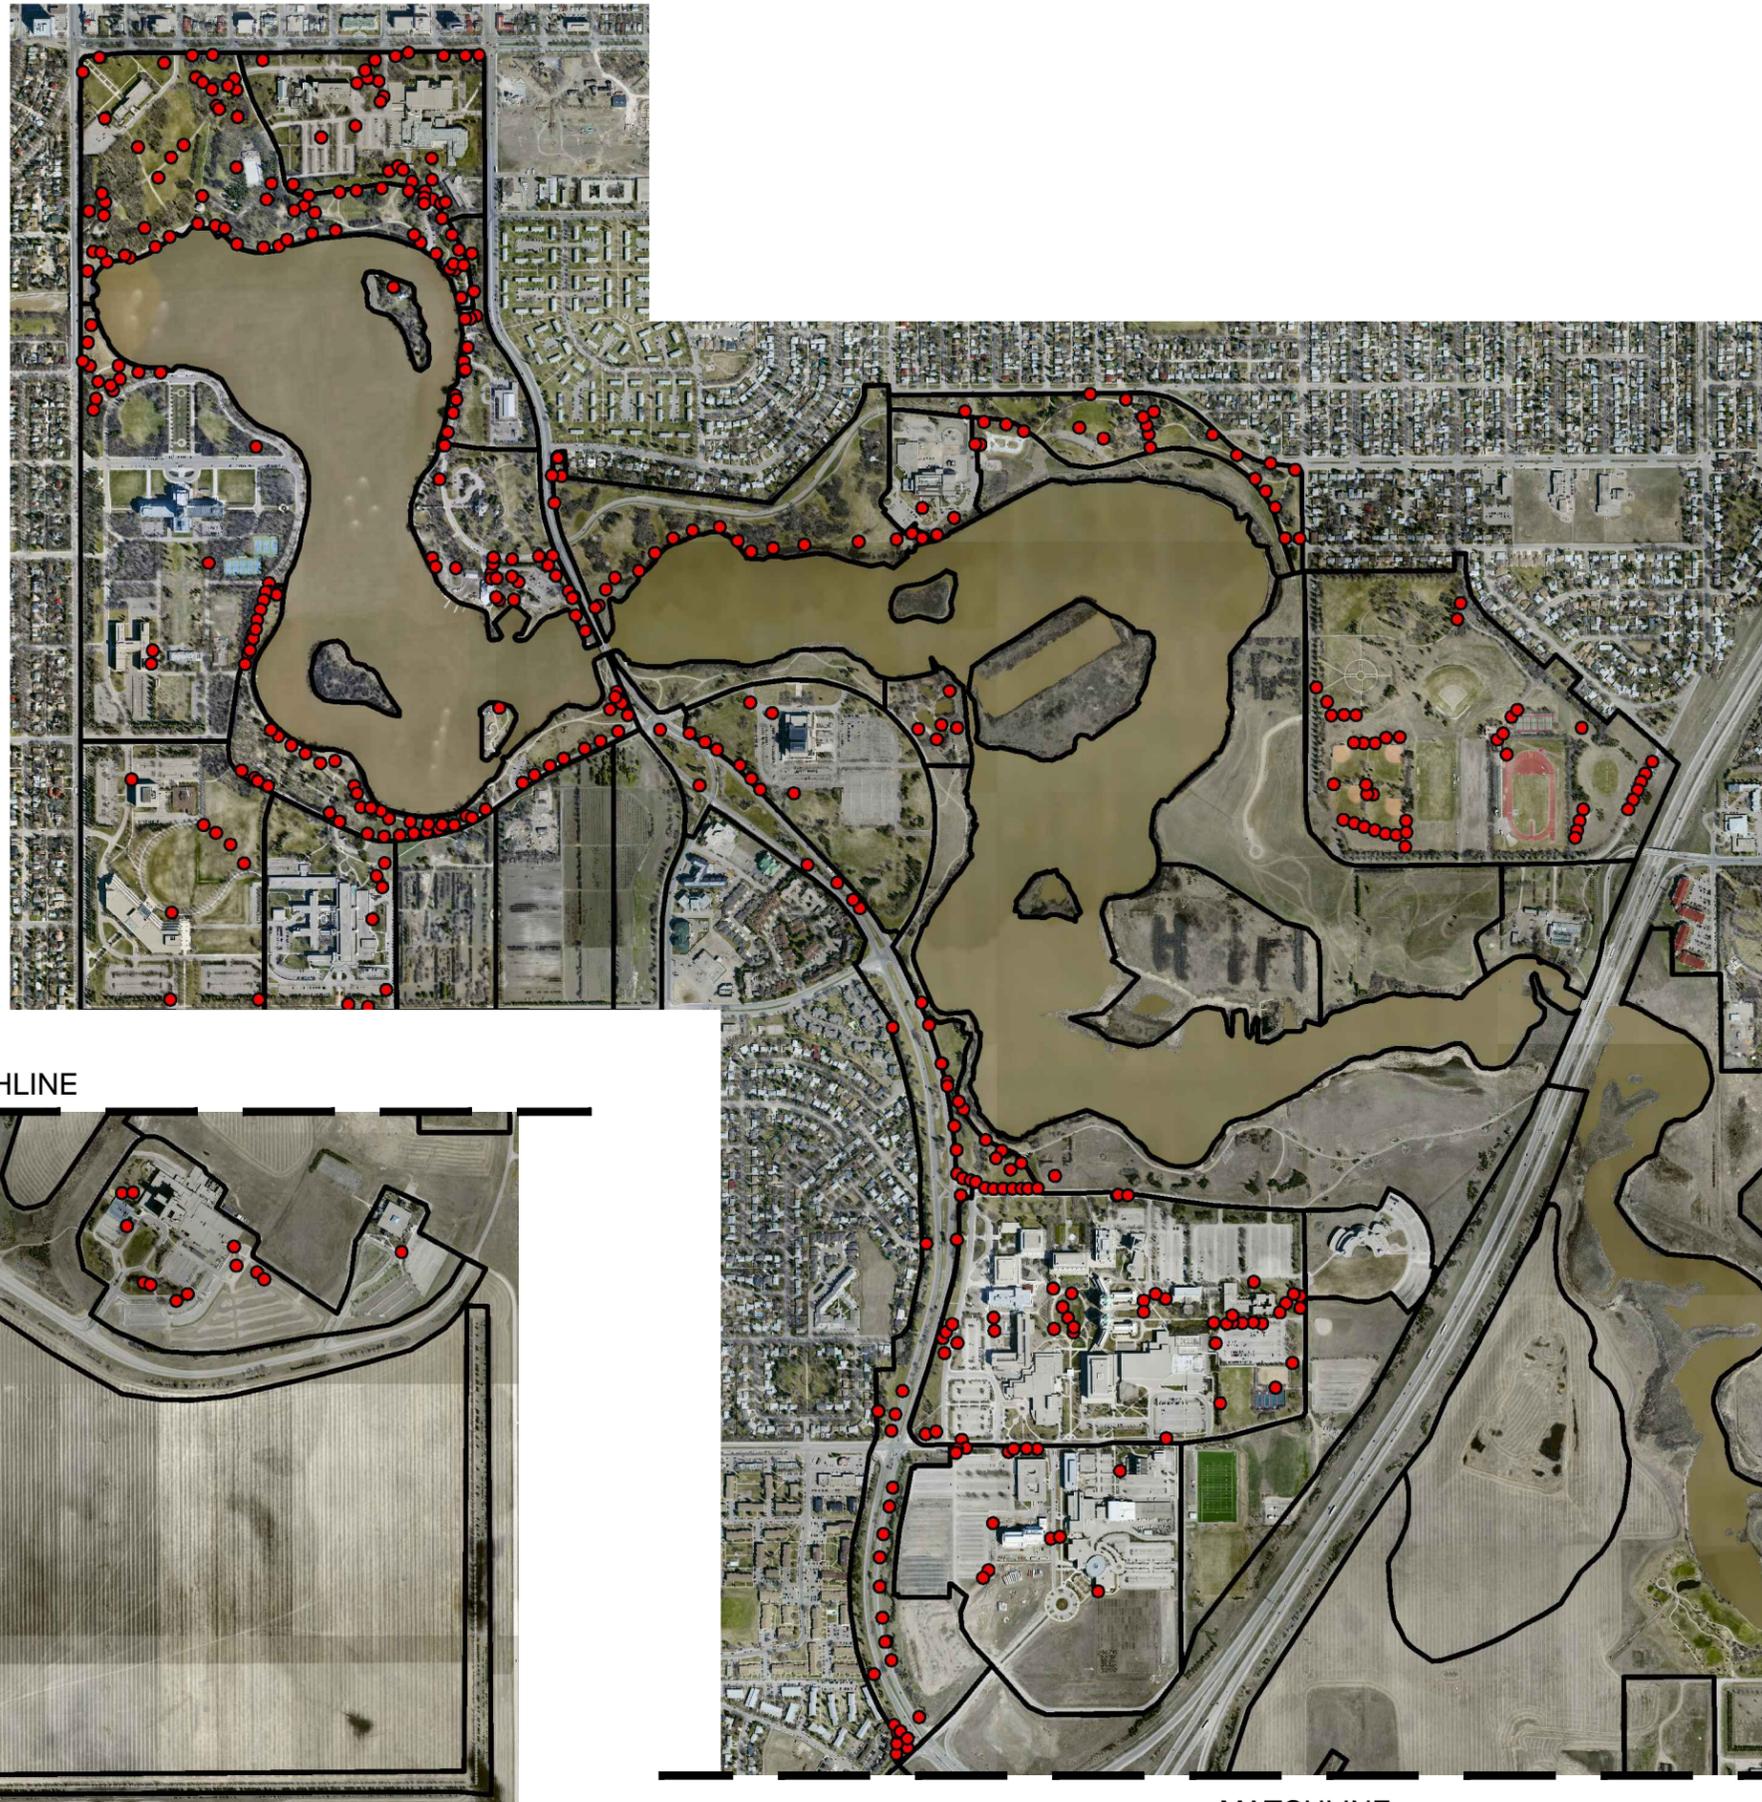
TURF IN CRITICAL CONDITION

During the field assessment, large patches of exposed soil from underground construction were found in areas such as Candy Cane Park, Performing Arts Centre and T.C. Douglas building. In Candy Cane Park and at the Performing Arts Centre these patches were from recent construction but around TC Douglas the soil appears to have been there for an extended period of time resulting in an uneven surface and the growth of large weeds. Along the South shore, the geese are prevalent on many of the lawns around the Legislative Grounds and the Performing Arts Centre areas. In these areas the grass has been grazed extensively creating a very short, thin cover, resulting in no competition and weeds. In all subareas, excluding the areas South of College Ave and Wascana Headland, ground squirrel holes are abundant throughout the turf. Around the holes there is often a large pile of soil which is unsightly. By pathways and areas of high traffic, these holes

become safety hazards for the park users. (Turf that has been assessed as critical is illustrated in Drawing L.3)

- Improve and upgrade irrigations systems throughout the Centre.
- Institute a policy of greater care by operating staff for established turf in considering the transport of equipment throughout the Centre.
- Implement a ground squirrel control program in areas of high pedestrian traffic to address public safety.
- Develop pathway system to address increased pedestrian traffic load

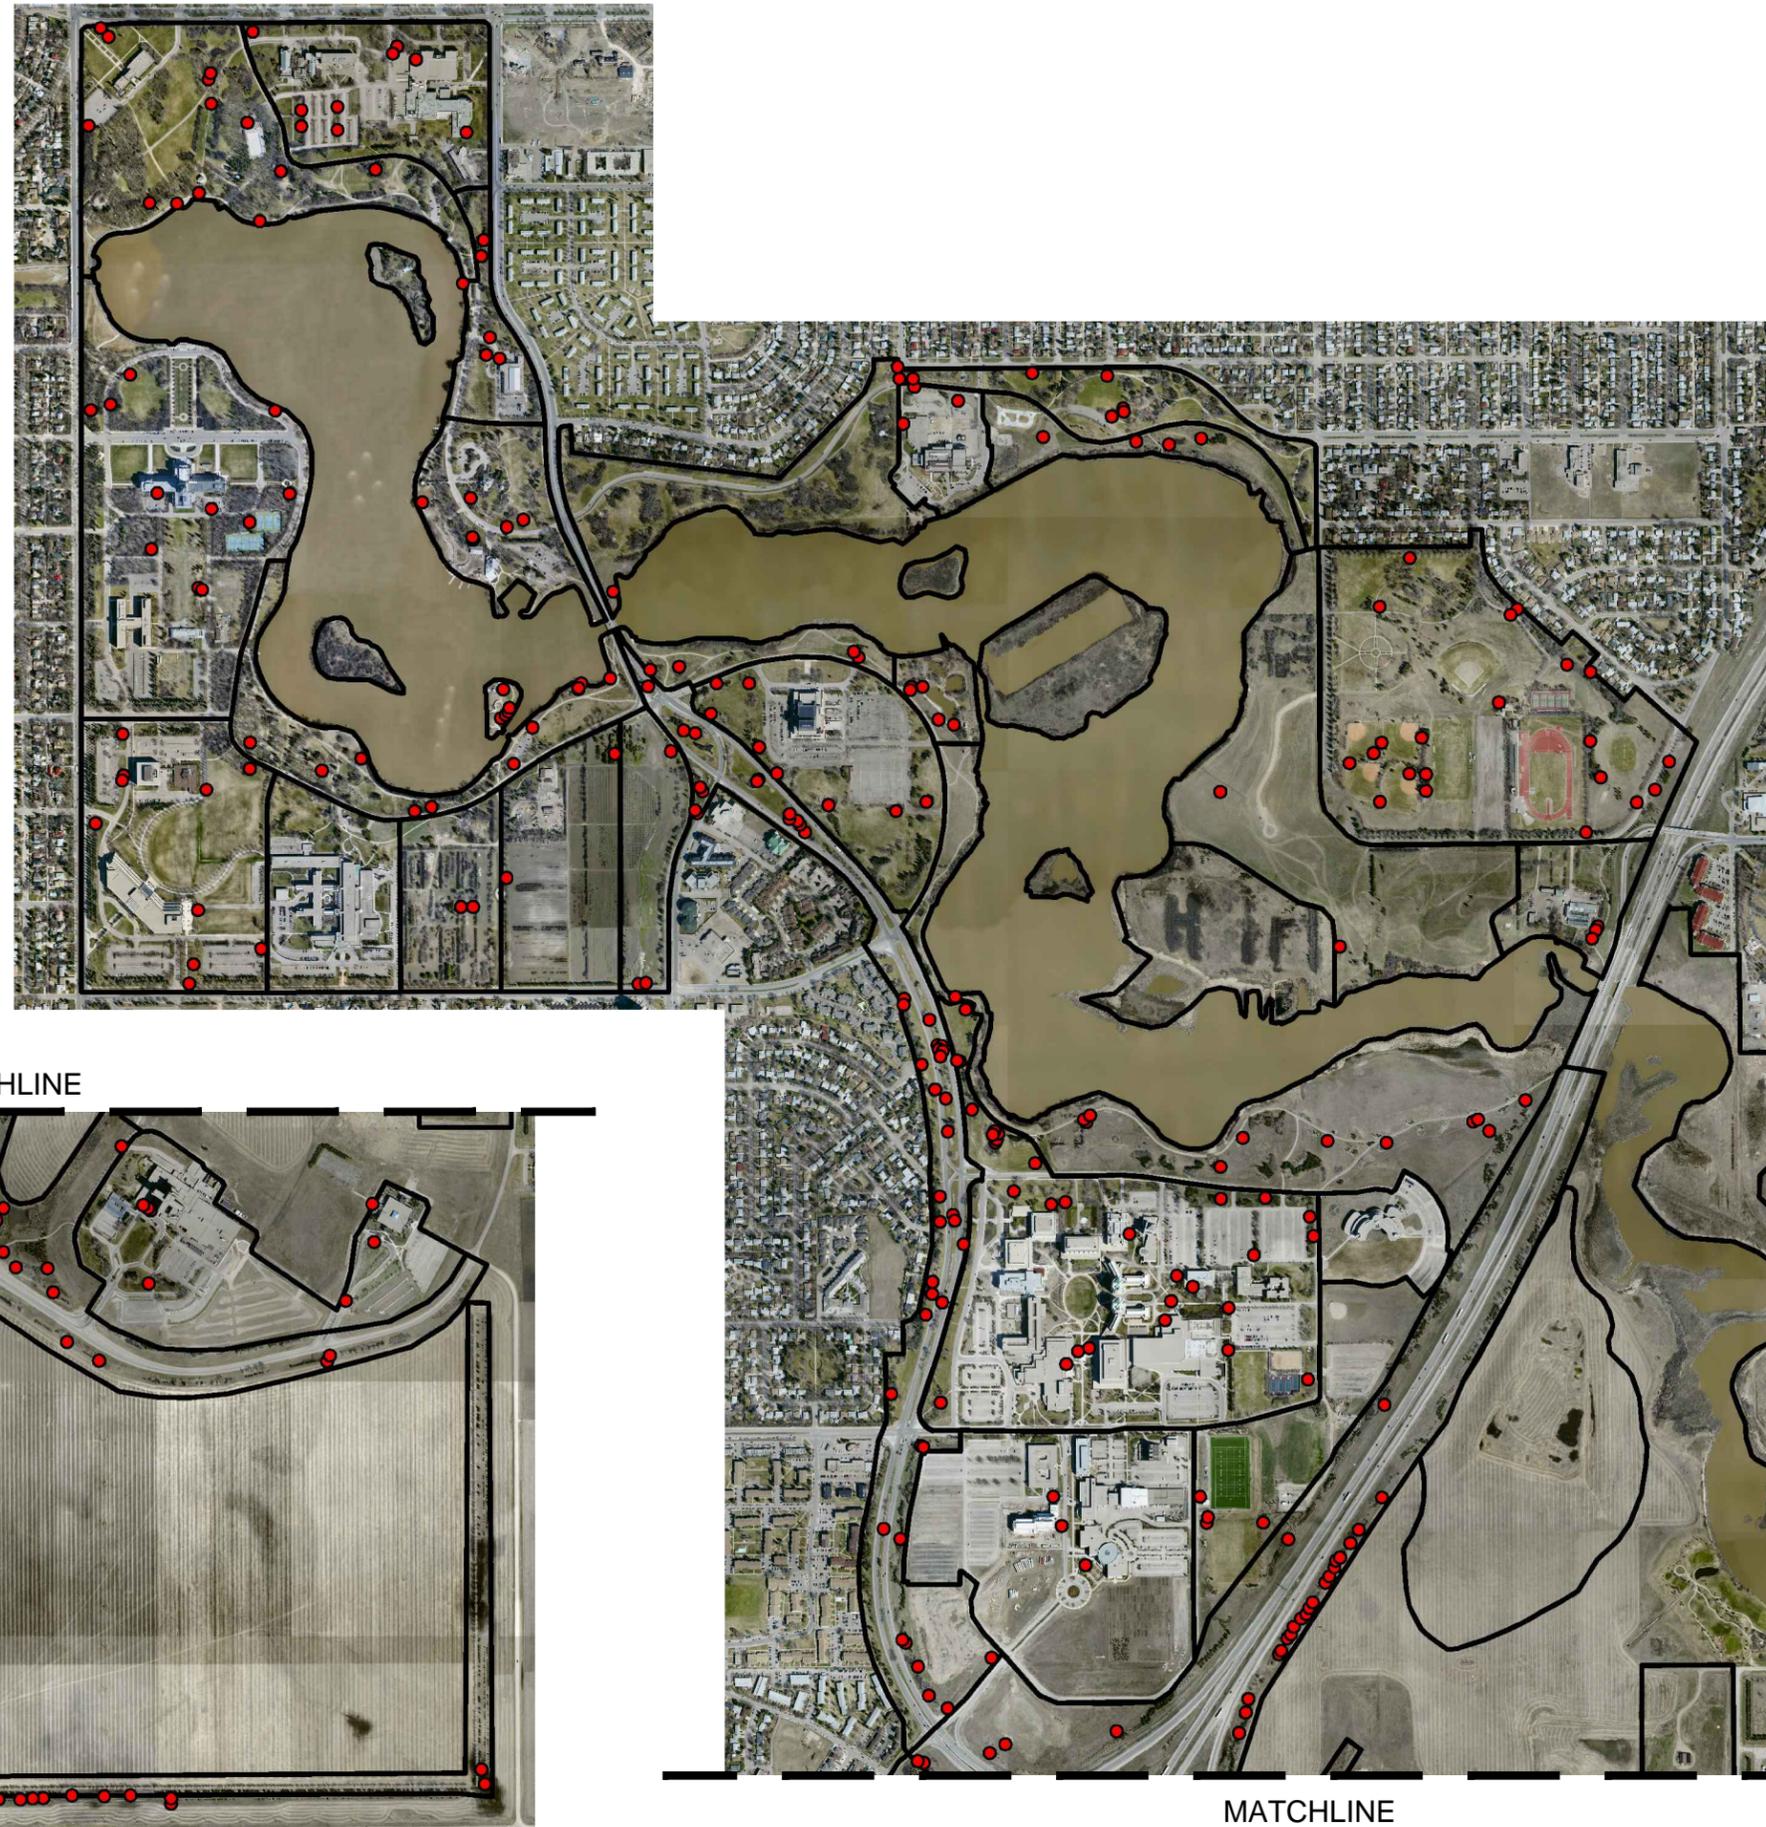
Project No. 12.026R | Drawing L.4

TREES IN CRITICAL CONDITION

- Institute an annual tree pruning program to achieve a once in ten year tree pruning cycle throughout the Centre for public safety, tree sanitation, preservation of older trees and prolonging the life and effectiveness of younger trees.
- Install tree guards at base of trunks of all young trees to prevent mechanical damage.
- Adopt a standard practice of maintaining a mulch cover for all tree beds throughout the entire Centre.
- Employ a long term plan to eliminate the use of rototilling as a means of weed suppression and replace cultivated areas with turf and/or shrub beds.

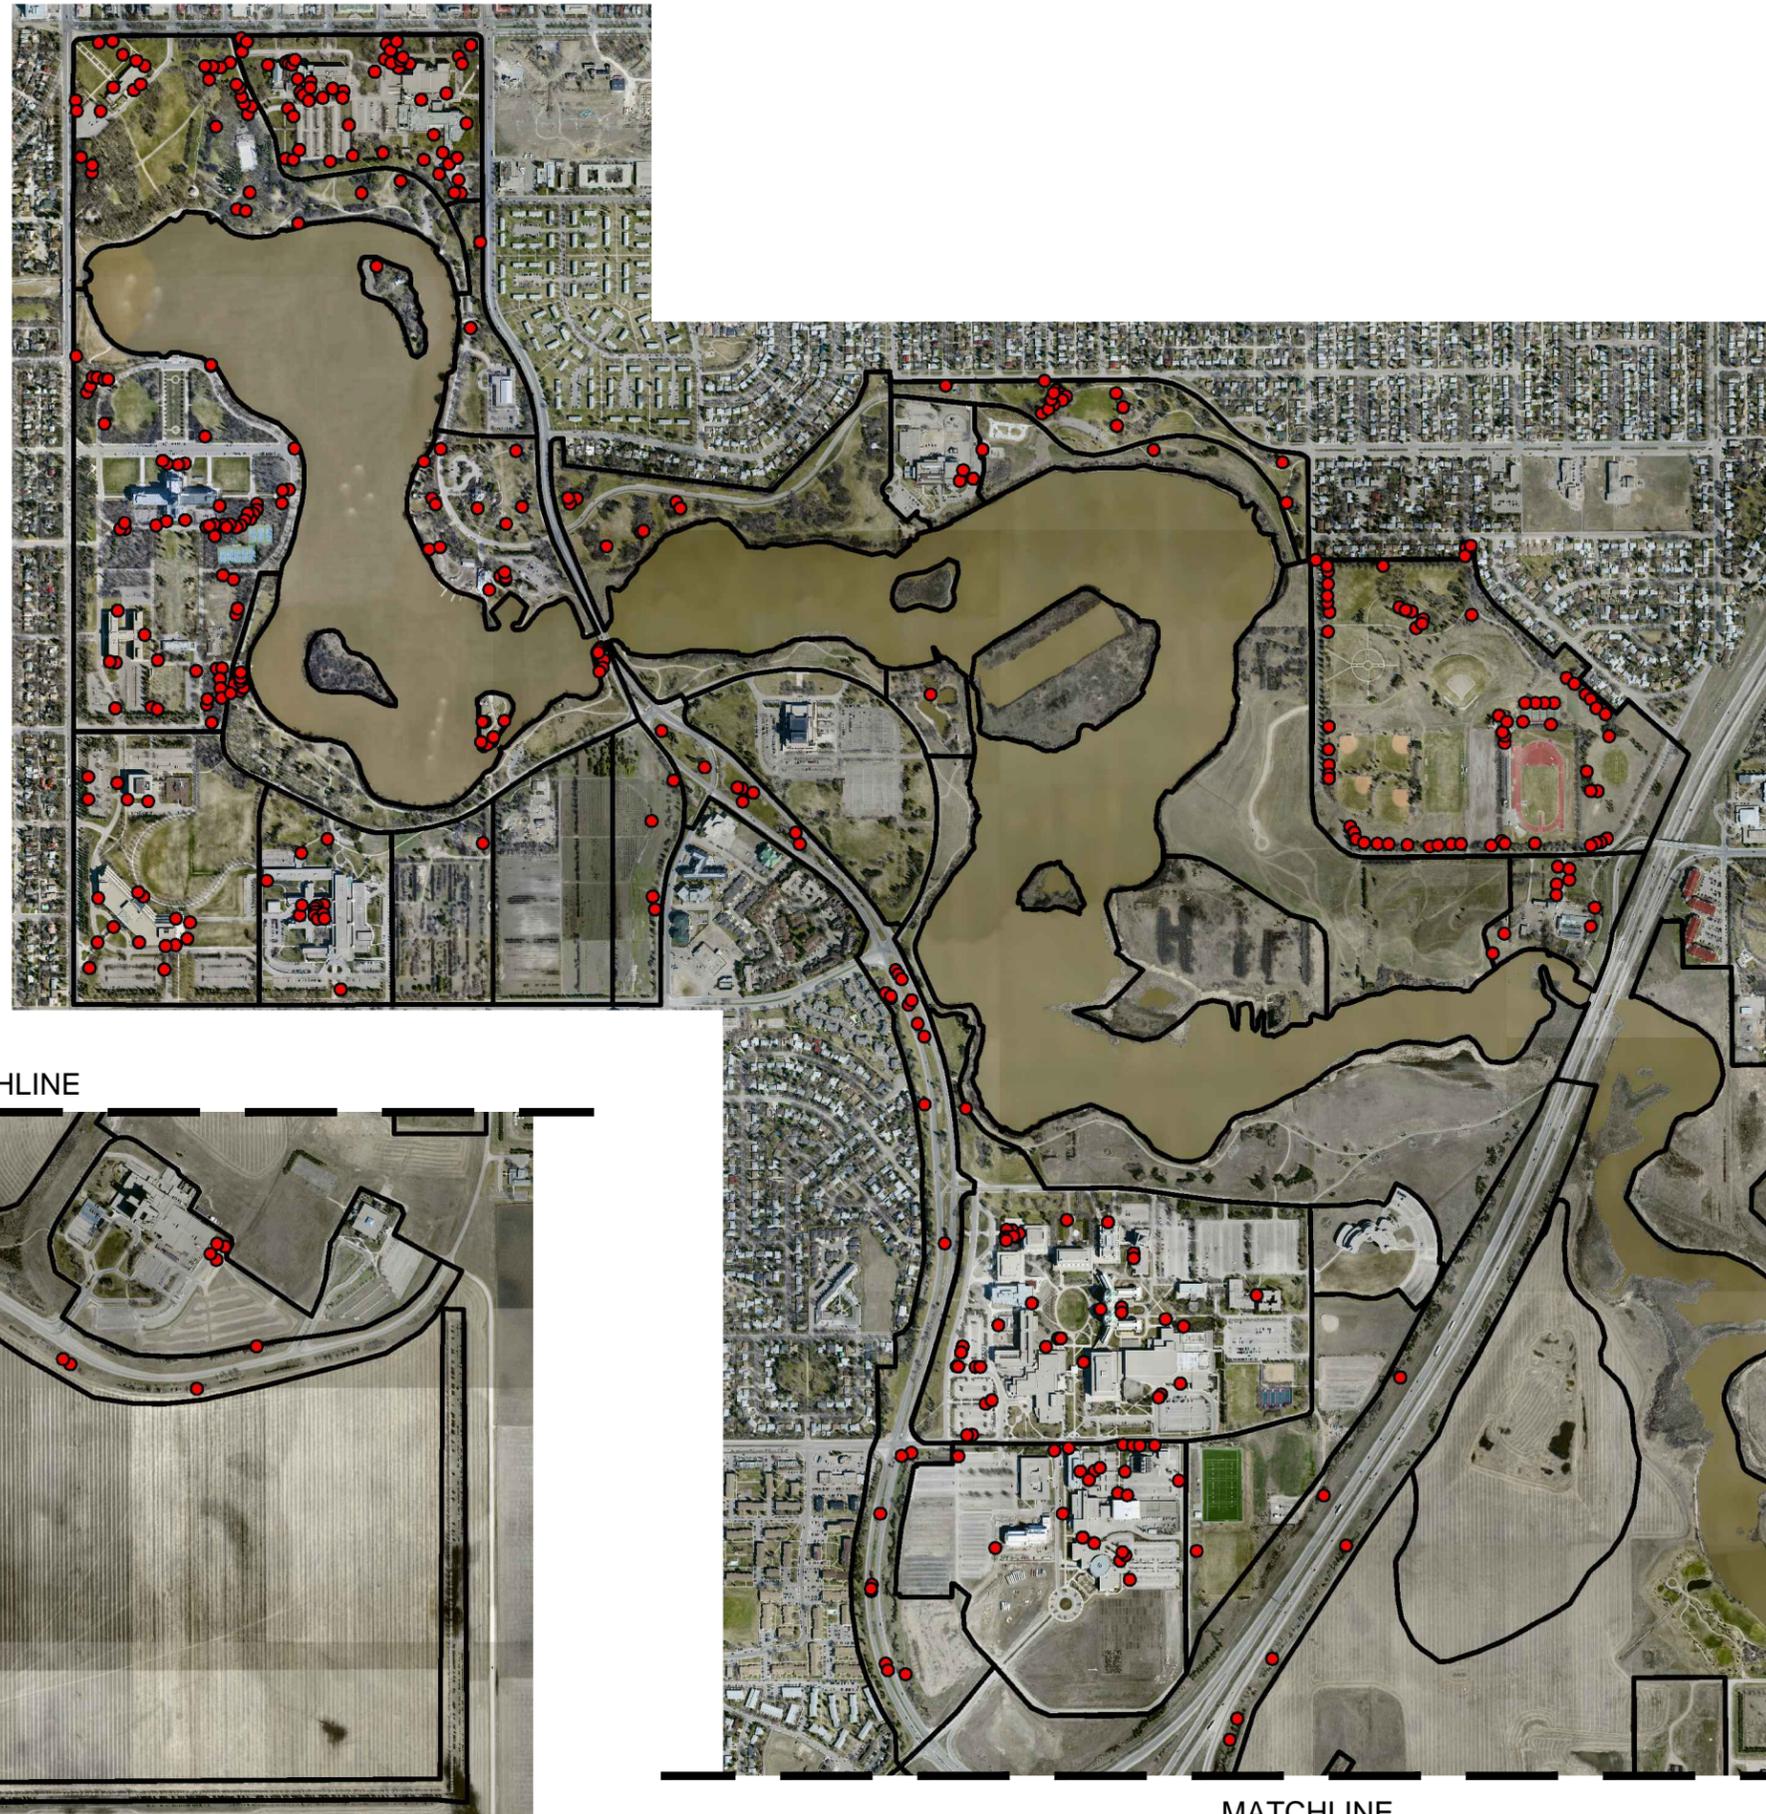
(Shrub beds in critical condition are illustrated in Drawing L.5).

- Thin, head back and remove shrubs as necessary from bed to create healthier, less dense shrub planting.
- Install and maintain a mulch cover for shrub beds throughout the entire Centre.
- Develop a park management strategy to replace shrubs that cannot be renewed by pruning or thinning, with a variety of alternate species better suited to different landscape applications to establish a species diverse ecosystem throughout WCA.
- Remove invasive shrub species particularly Caragana wherever that plant population threatens the establishment or survival of other plant species in the designed or natural landscape. Over the long term, removal of Caragana is recommended and replacement with alternate indigenous plant species is recommended.
