# Wascana Centre Authority

## Comprehensive Review Project

#### Building and Infrastructure Assessments

# Report

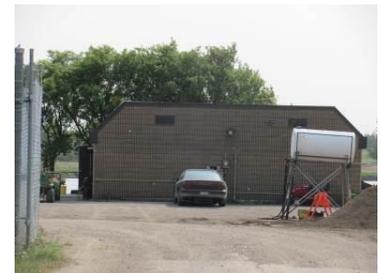
#### **2.2.4 551E Assiniboine Ave – Area 4 Service Depot (Area 6)**

The facility substructure consists of concrete strip footings, foundation walls, and slab on grade. Exterior walls are clad with cadenza concrete masonry units. Exterior windows are single glazed units set in wood frames. These windows are worn and energy inefficient and require replacement. Exterior passage doors include insulated steel units. Other doors include three 10' x 11' overhead doors that are worn and are approaching the end of their serviceable life. The roof covering is a BUR roofing with sheet metal flashing. BUR roofing contains soft spots and has approximately 5 years remaining.

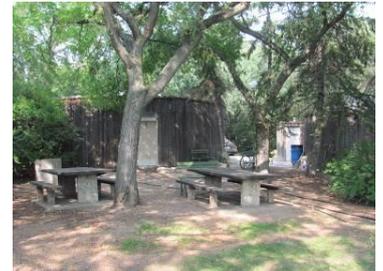
### 2.2.5 2860 Wascana Drive – Goosehill Service Depot (Area 4)

The facility substructure consists of a concrete foundation and slab on grade. Exterior walls are clad with wood siding which is damaged and requires attention. Two exterior passage doors are insulated steel. The door at the fuel storage shed has a damaged frame and the paint has deteriorated on both the fuel storage room door and the main entrance door. There are two overhead coiling doors – one to the garbage storage and the other to the main shop area. Both are in good condition however the jambs require replacement. The flat roof covering appeared to be in good condition and was recently replaced. The building has no windows but instead has eight acrylic skylights.

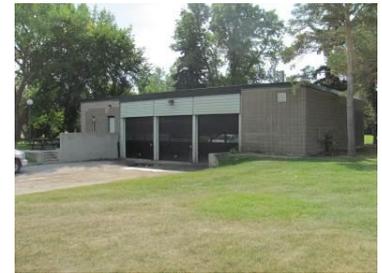
### **2.2.6 1955 College Ave – Area 2 Service Depot (Area 1)**

The building is founded on cast in place concrete strip footings and slab on grade. The glulam timber roof beams with tongue and groove fir decking are supported on load bearing interior and exterior concrete masonry with fluted 'Cadenza' exterior finish. The mechanical mezzanine floor is constructed of 2 x 6 joists at 12" on centre. The span of the joists is of concern and may require additional support. Retain a structural engineer to analyze and make recommendations for remediation. This issue should be repaired as soon as possible. The exterior windows are double glazed sealed wood units with localized rot and should be replaced. The exterior passage doors are metal clad and the three overhead doors are wood. The BUR roofing requires replacement.

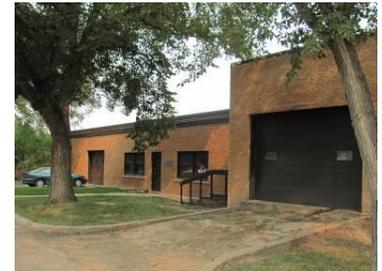
### 2.2.7 Area 1 Service Depot (no Civic Address, by Legislature) (Area 3)

Substructure components noted during the assessment include a cast concrete floor that had significant damage and requires replacement. It was noted that a concrete basement (104' x 32') is located nearby and is deemed a liability. The wood stairs leading into the building are deteriorating and require attention. Exterior walls are clad with a brick veneer and were noted with extreme cracking that requires further analysis. Due to the extreme cracking and shifting of the concrete foundation, exterior brick walls and interior concrete masonry units, a structural consultant should be retained to analyze the condition of the building and makes recommendations for correction. Exterior windows include sealed aluminum framed units as well as single glazed wood framed units that should be replaced. Exterior doors include a steel clad door with a worn paint finish and solid core wood doors that are dated and worn. Three overhead doors were in place. The roof covering consists of both tar and gravel (BUR), and a bituminous sheet membrane (BUR).

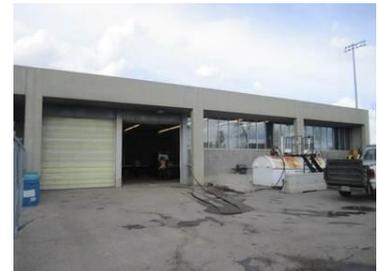
### **2.2.8 Campus Service Depot A (Area 7)**

The facility substructure consists of concrete strip footings, foundation walls, and slab on grade. Exterior walls are concrete masonry units with wood soffits. The pointing is damaged on the CMU wall. Exterior passage door include an exterior aluminum door. Other doors include two 12' x 12' overhead doors. One unit is constructed of a vinyl/plastic material while the other is wood constructions. Both overhead doors are damaged and worn. Access to the roof was not permitted.

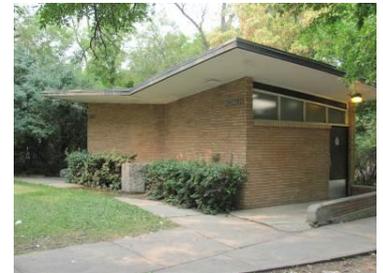
### 2.3.1 2801 Albert Street – Washroom #1 Legislature (Area 3)

The facility is supported on a concrete slab on grade. The ground should be re-graded to slope away from the building. The walls are wood stud construction with brick on the exterior. Some graffiti was noted during the site visit and caulking at the masonry joints requires replacement. The roof is wood framed with built up roofing and is in fair condition however the plaster coating at the soffits needs repair. Wired glazing set in wood frames is cracked in at least three panels and the paint is worn. The three steel passage doors require repainting. There are two skylights in the building and they are in good condition.

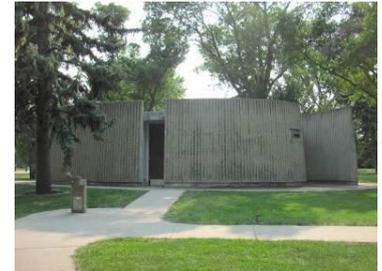
### **2.3.2 3200 Lakeshore Drive – Washroom #2 (Area 3)**

The facility is supported on a concrete slab on grade. The walls are cast in place concrete construction with a bush hammered fluted face. The roof is also cast in place concrete. The paint on the three steel passage doors is worn and the wooden transoms are rotting and will soon require replacement. There are two 36" diameter skylights in the building and they are in fair condition. The BUR roofing is in poor condition and should be replaced along with the associated flashing and trim.

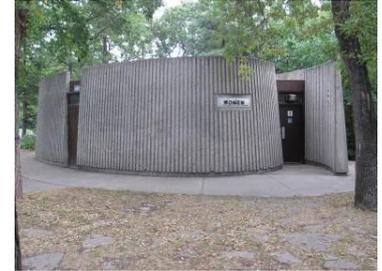
### 2.3.3 Washroom #3 (Area 1)

The facility is supported on a concrete slab on grade. The walls are cast in place concrete construction with a bush hammered fluted face. The roof is also cast in place concrete. The three steel passage doors are in good condition. There are two 36" diameter skylights in the building and they are in fair condition. The BUR roofing is in poor condition and should be replaced along with the associated flashing and trim.

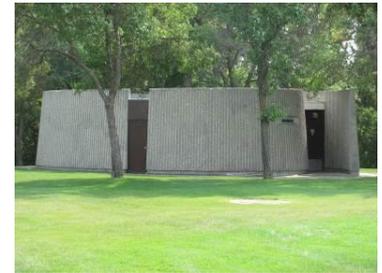
### **2.3.4 Washroom #4 (Area 4)**

The facility is supported on a concrete slab on grade. The walls are cast in place concrete construction with a bush hammered fluted face. The roof is also cast in place concrete. The three steel passage doors are in good condition. There are two 36" diameter skylights in the building and they are in fair condition. The BUR roofing is in poor condition and should be replaced along with the associated flashing and trim.

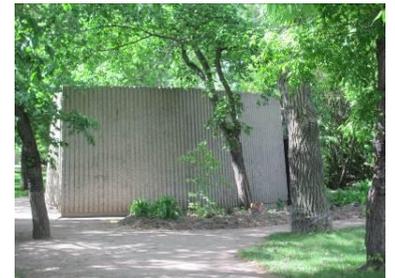
### 2.3.5 Willow Island Washroom #5 and Associated Staff Space (Area 1)

The building is situated on a concrete slab on grade and comes with a precast concrete roof structure. Exterior doors are standard hollow core steel units. Skylights are installed in the washrooms and are in fair condition.

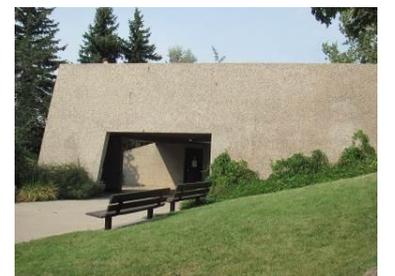
### 2.3.6 Washroom #6 (Area 6)

The facility is supported on a concrete foundation. The walls are cast in place concrete construction with an exposed aggregate finish. Some localized spalls and cracks require repair. The roof is precast concrete and is supported on the exterior walls and the interior concrete masonry block load bearing walls. The roof is partially buried and a membrane system is exposed and damaged in places. Exterior doors are painted steel and the finish has deteriorated.

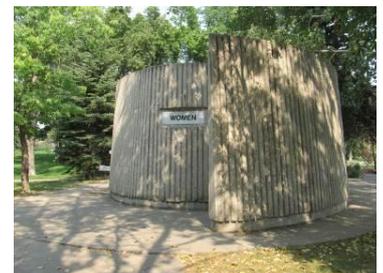
The facility is supported on a concrete slab on grade. The walls are cast in place concrete construction with a bush hammered fluted face. The roof is also cast in place concrete. The three steel passage doors are in good condition. There are two 36" diameter skylights in the building and they are in fair condition. The BUR roofing is in good condition.

The interior partition walls are wood framed with painted plywood and gypsum board. Some of the wood has rotted and the gypsum board is damaged requiring replacement and repair. Toilet

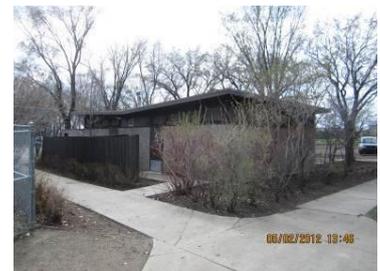
#### 2.3.8 Douglas Park Washroom (Area 6)

The concrete slab is cracked and requires repair or replacement. The roof structure is supported by concrete masonry block walls which exhibit several cracks. In one location, a steel telepost that supports the timber roof framing has been removed. It is unknown whether the steel post removal had been reviewed by a structural engineer. A engineer should be retained to analyze the facility's structural components and make recommendations for remediation. The membrane on the roof has failed and is leaking and fascia and soffit require repainting. Some of the 20 single glazed wood framed windows have cracked and should be replaced. Two steel doors are in fair condition, and one solid wood door is worn and should be replaced with a steel door.

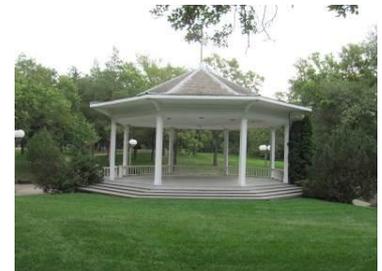
### **2.4.1 19th Ave & Smith St – Bandshell (Area 1)**

The flooring of the bandshell consists of 2x6 timber decking on 2x10 timber joists. Some of the boards are rotting and require replacement. The aluminum stairs are in good condition. The cedar shake roofing, galvanized ridge caps, galvanized flashing, and the timber framing supporting the roof appears to be in good condition. An attic hatch is framed through the 4" tongue and groove timber ceiling cladding.

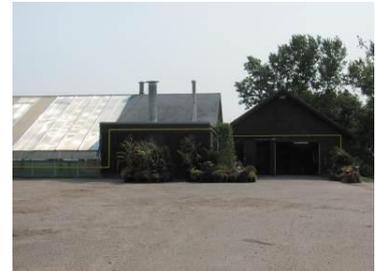
### 2.4.2 217E Assiniboine Ave Greenhouse Complex including the Header House (Area 6)

Exterior walls are clad with numerous types of construction including CMU, metal siding, cementitious stucco, wood siding and glass and polycarbonate material for the greenhouses. The CMU, wood siding and glass exterior walls are all worn or damaged. A significant amount of water was noted in the concrete bunker area of the facility. A structural consultant should be retained to analyze the foundation of the building and make recommendations for remediation. Exterior windows are primarily sealed units set in wood frames with some upgraded PVC units installed. Exterior passage doors include both solid core wood and insulated steel units. The large wood exterior doors should be replaced by a steel overhead door. Other doors include a 9'x7' steel overhead door and 11' x 9' wood overhead door. The wood overhead door is worn and requires replacement. The roof covering is a rolled bituminous membrane (SBS), an inverted roofing system, asphalt shingles, sheet metal and glass/polycarbonate panels for greenhouse. The inverted roof section requires replacement.

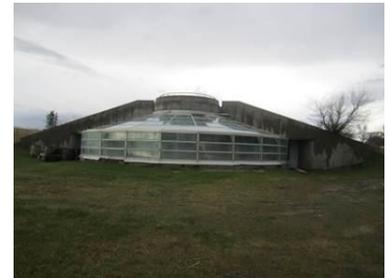
### **2.4.3 300E Assiniboine Ave – Overwintering Structure (Area 6)**

Substructure components noted during the assessment include cast concrete foundation walls and a slab on grade. The exterior windows are sealed units in fixed frames that were installed in 1979. Many come with failed seals and require replacement. Exterior doors are steel clad and have worn paint finishes.

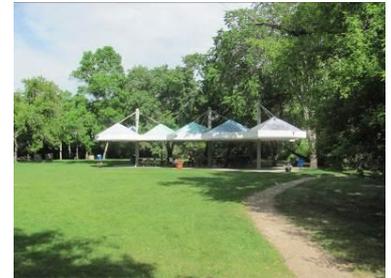
### 2.4.4 Willow Island Covered Picnic Area (Area 1)

The structure sits on a concrete foundation. The concrete foundation was noted to have minor cracking. Patch cracks and monitor. Four triangular steel columns hold up 12 fibreglass hexagon shaped canopies. Connections between the top of the columns and the roof panels are provided by steel rods with turnbuckles. The columns, rods and roof panels are all in good condition. The fibreglass roofing units are painted. Paint finishes on the roof are worn and require painting.

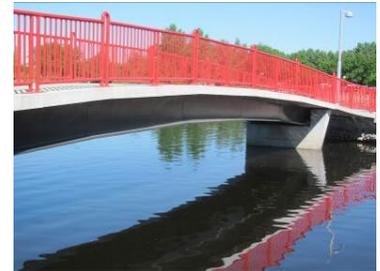
### 3.7.1 Broad Street Pedestrian Bridge (Area 2)

The bridge was constructed in 2010 and is a three span steel girder main span bridge with cast in place deck jump spans and concrete deck. The bridge is in very good condition.

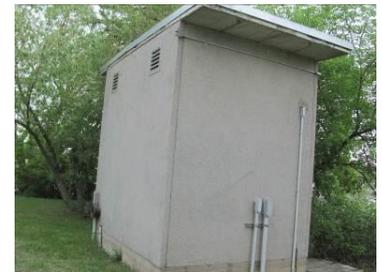
#### **3.8.4 Nursery Pump House (Area 3)**

The pump house structure consists of a cast in place concrete slab with cast in place walls and precast concrete roof structure.

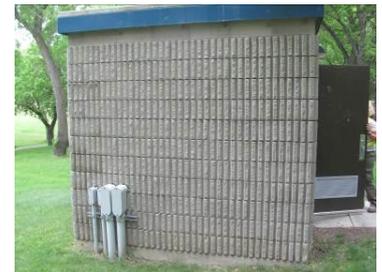
### 3.9.1 North Aeration System and North Lake Fountain (Area 1)

The aeration equipment is supported on a slab on grade complete with architectural concrete block walls and a flat concrete roof.

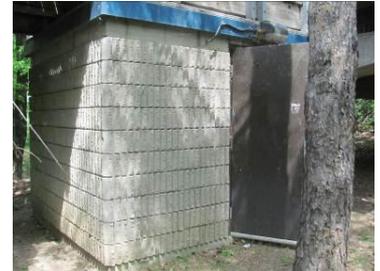
The lake's south aeration system compressor and controls are housed in a building under the Trafalgar Overlook. The aerators and submersible fountain pump are installed at the bottom of the lake. The aeration system and fountain were installed in 2002.

The aeration equipment is supported on a slab on grade complete with architectural concrete block walls and a flat concrete roof. The concrete slab is unpainted and the interior has painted plywood on the walls and ceiling. The building is in good condition.

The reciprocating air compressor is in good condition. However a blower may be a better solution than a reciprocating compressor to supply air for the aerators. The compressor has a low efficiency and most of the energy is spent in wasted heat, which increases the temperature in the building and reduces the life of the compressor and other components. Rotameters which measure the air flow in the aerators have become filled with debris from the compressor and are no longer functional. The pressure gauge has also been damaged by high temperatures and debris from the compressor and requires replacement. According to WCA operations staff, the aerators and instrumentation were installed in 2004. An exhaust fan should be considered to assist in removing waste heat generated by the equipment from the building.

The aerators and the fountain submersible pump are installed at the bottom of the lake and were not accessible for review. However, WCA operations staff reported that one of the submersible fountain pumps had failed due to the pump type and installation. The submersible pump selection should be reviewed to ensure it is the proper type of pump for the intended purpose.

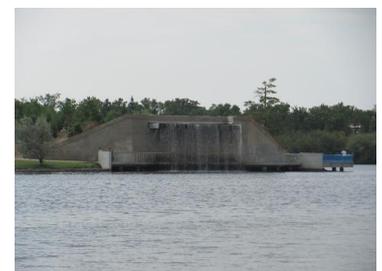
The waterfall trough is fastened to an existing cast in place concrete bridge abutment and a walkway passes underneath the waterfall. It consists of galvanized steel HSS 102X102 at 1350 on centre, wide flange beams,

steel plate/deck, aluminum railing and FRP grating.

The self-priming waterfall pump had failed shortly before the site assessment – the pump was new and being run for the first time.

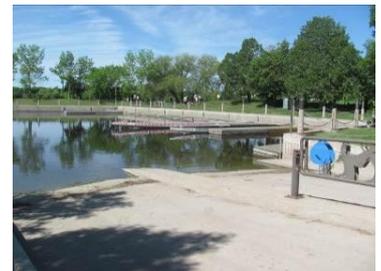
The Wascana Marina docks are constructed of 2x6 pressure treated plywood decking with 2'x6' cross members at 2' on centre. There are 24 docks. Year of construction is unknown. Some light damage is visible. Metal connections are in good shape, some localized rust. Dock #14 South (not labelled) has a chipped and damaged connection to Dock #14 West Dock that should be repaired.

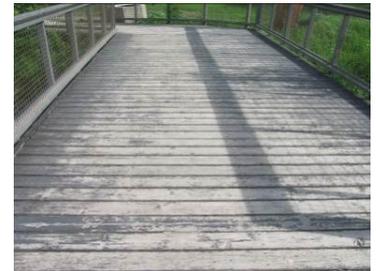
The overlook was constructed in 1968 and consists of steel framing, timber decking and concrete pile supports. In fair condition overall, there are indications that the abutment foundation wall may have moved and requires stabilization.

A steel bearing plate at the abutment has crushed the grout underneath; therefore the grout requires replacement and the anchor bolts should be repaired. The timber decking also requires repainting and localized repairs.
